Special Situation Report

U.S. Army Corps of Engineers
Omaha District

Low Dissolved Oxygen Levels in Summer Powerplant Discharges from Fort Randall Dam, South Dakota

Report Number: CENWO-ED-HA/SSR/Fort Randall Tailwaters/2010

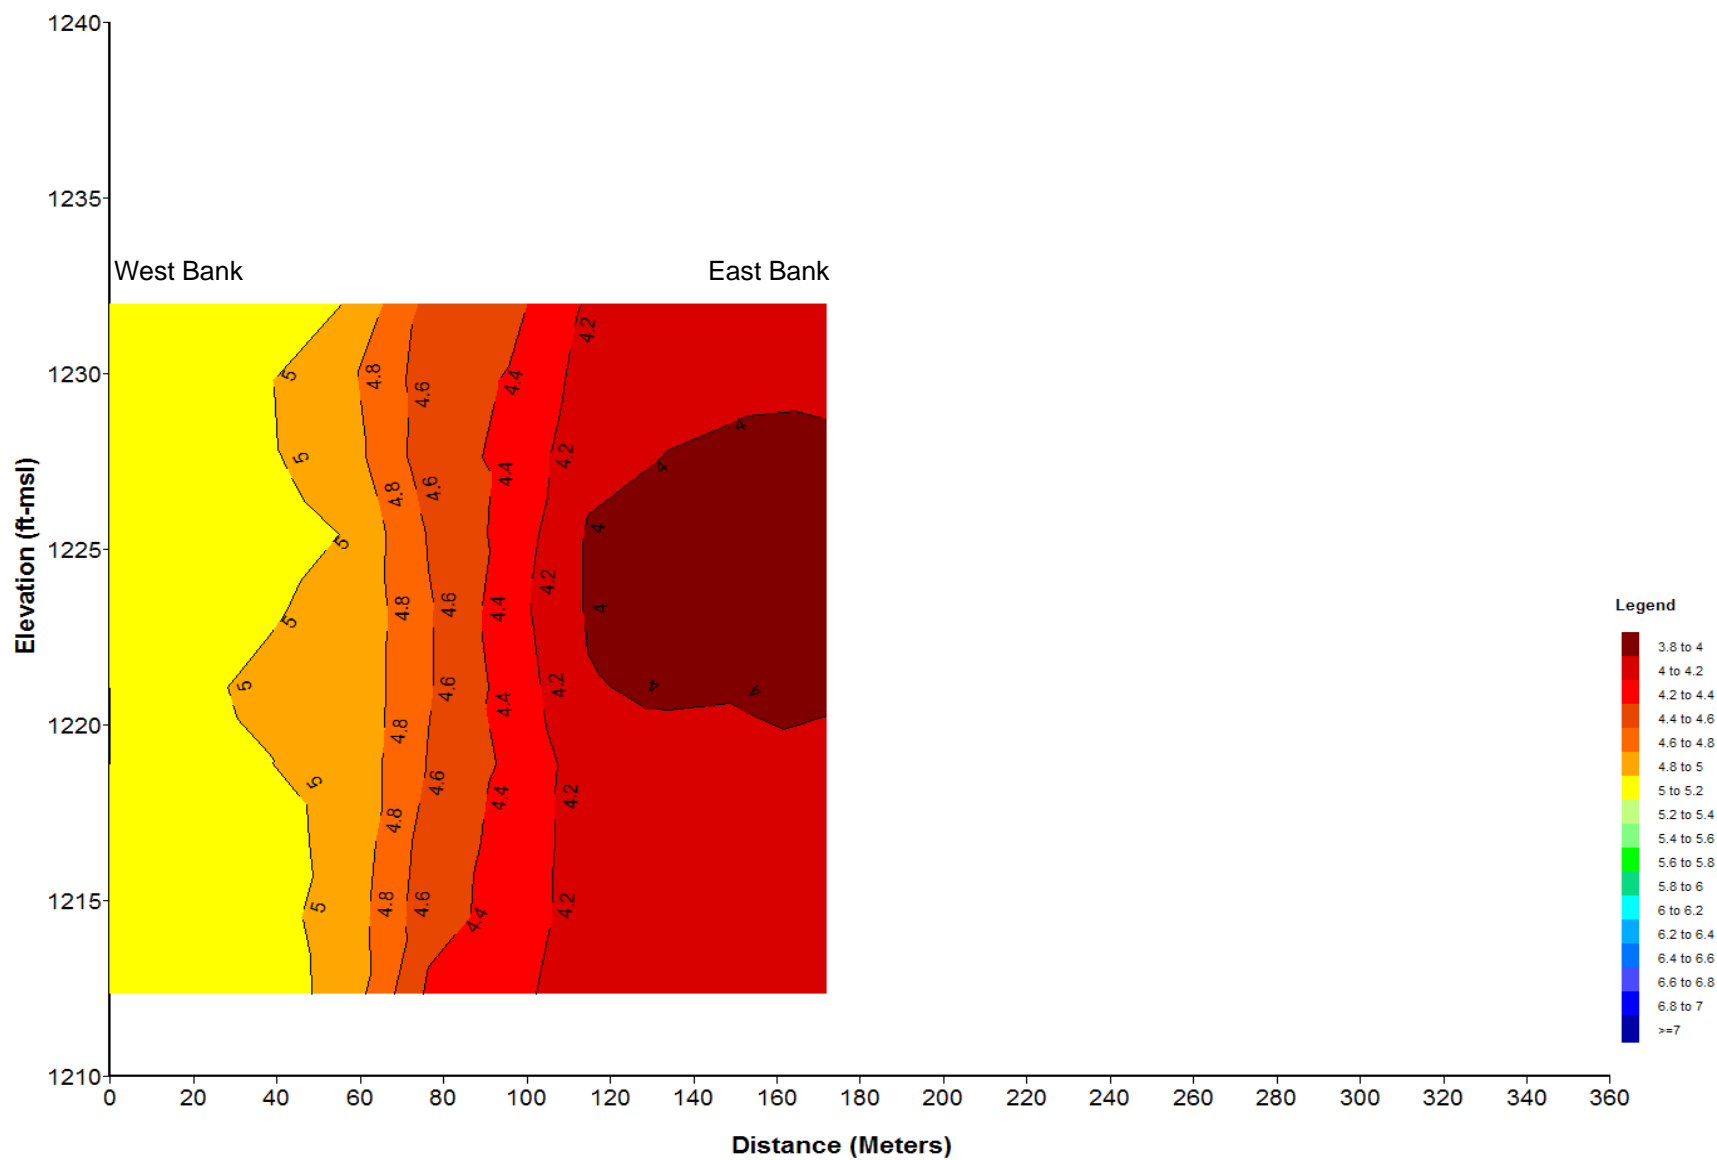
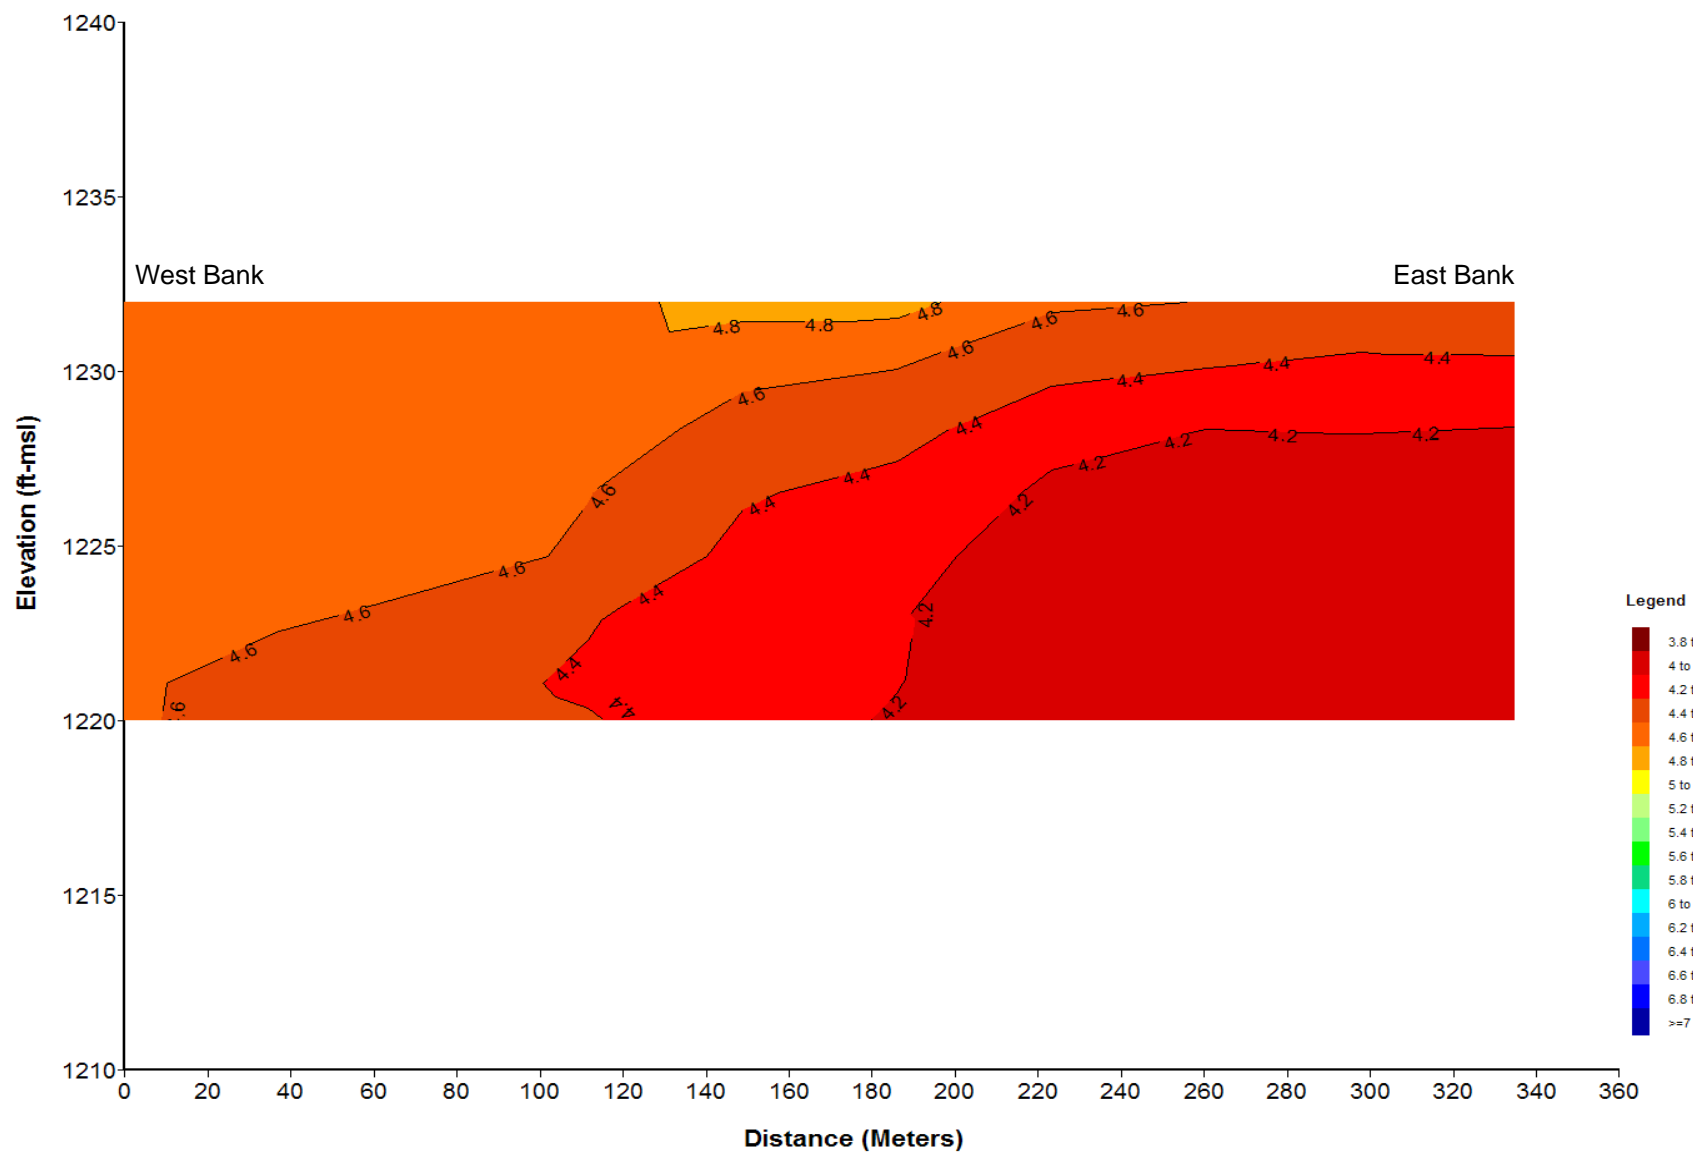
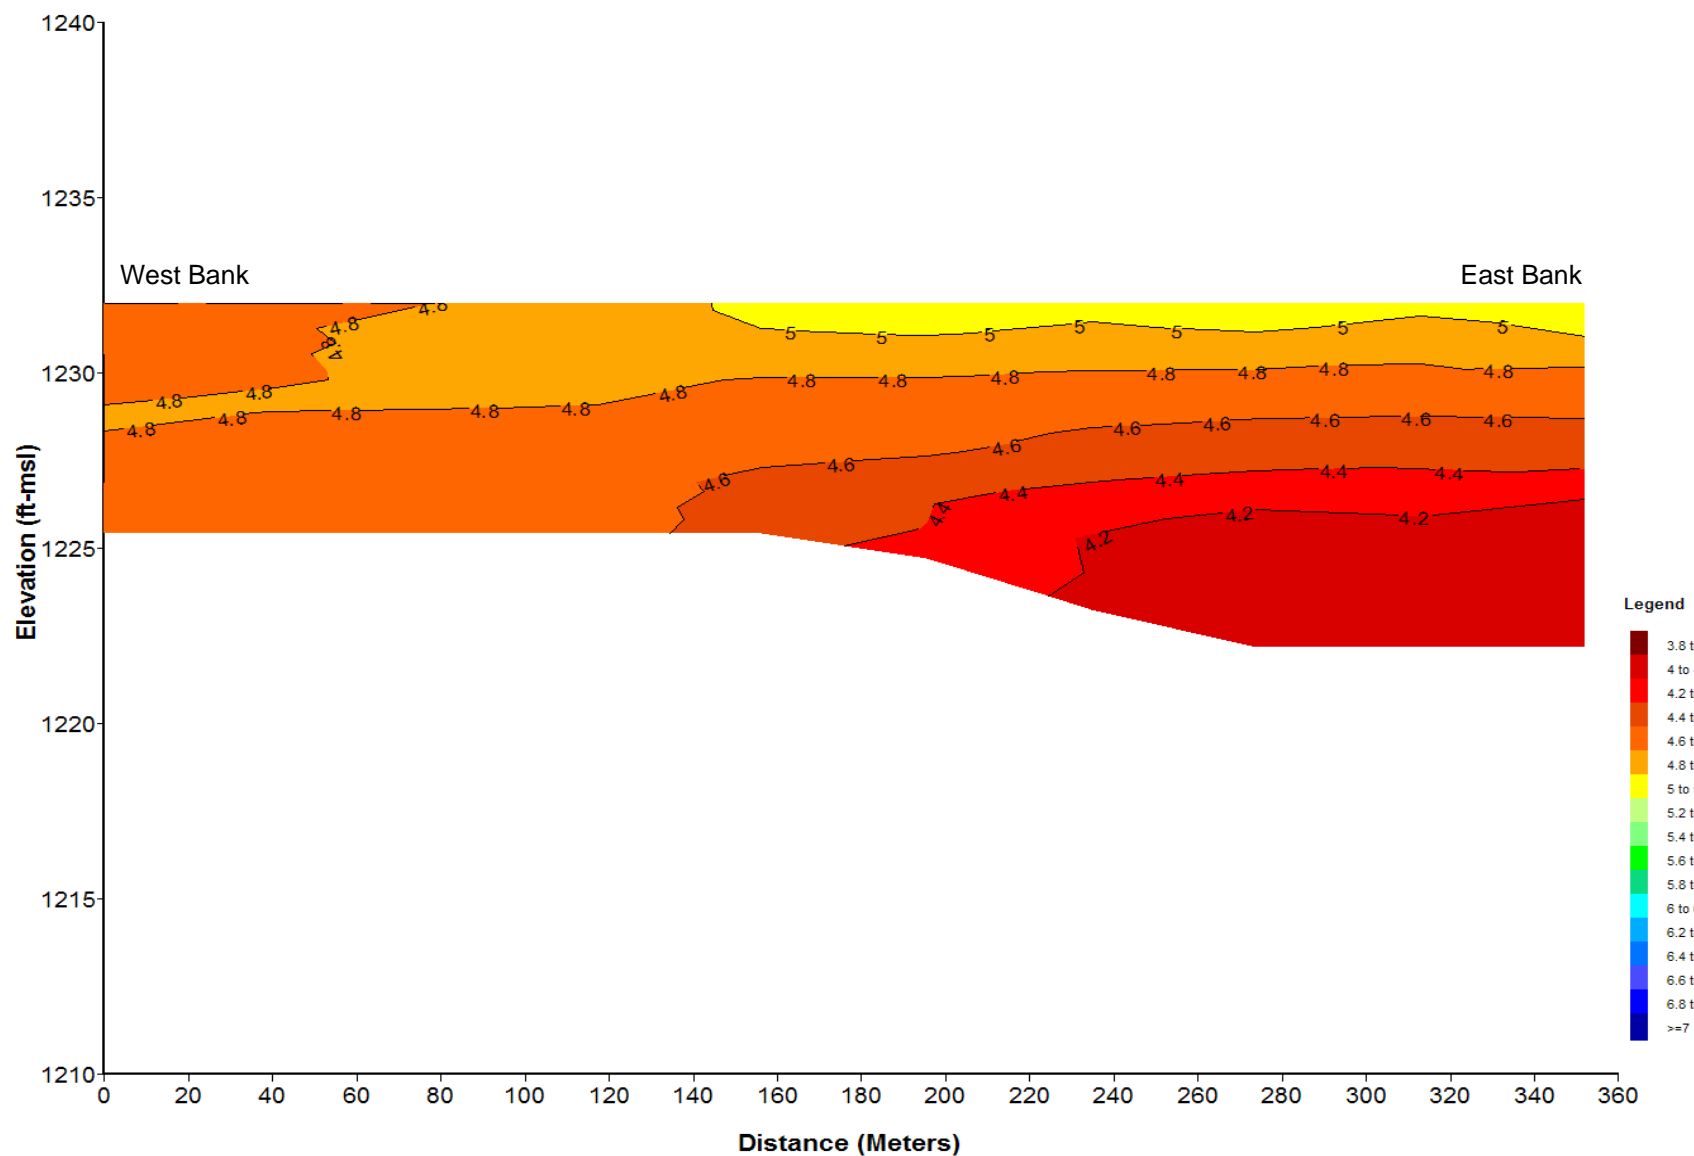
Figures 19, 20, and 21, respectively, display transect contour plots that were constructed to depict the dissolved oxygen concentrations measured across the Fort Randall Dam tailwaters at the near-dam (FTRTW3), spillway confluence (FTRTW2), and downstream (FTRTW1) sites on 27-July-2010. Figure 22 displays an aerial contour plot of the water-column average dissolved oxygen concentrations in the tailwaters based on the 1-meter incremental depth-profile measurements.

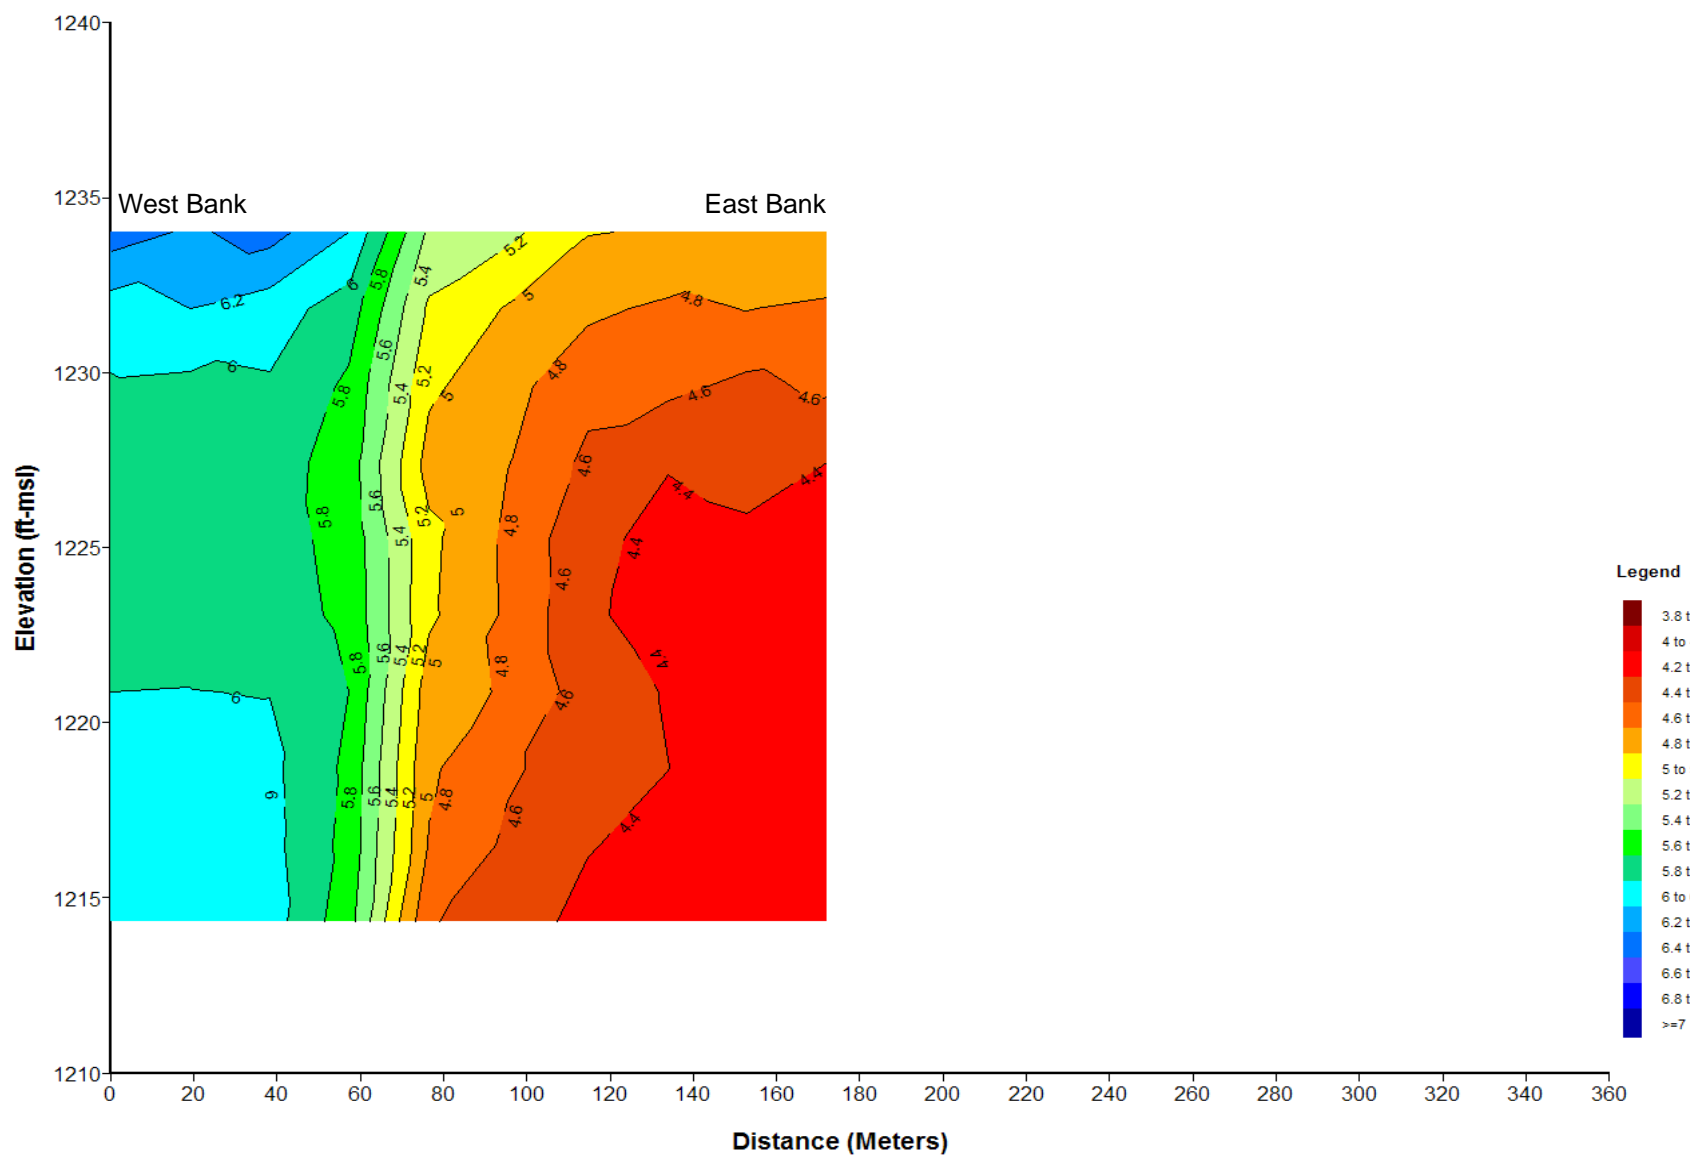
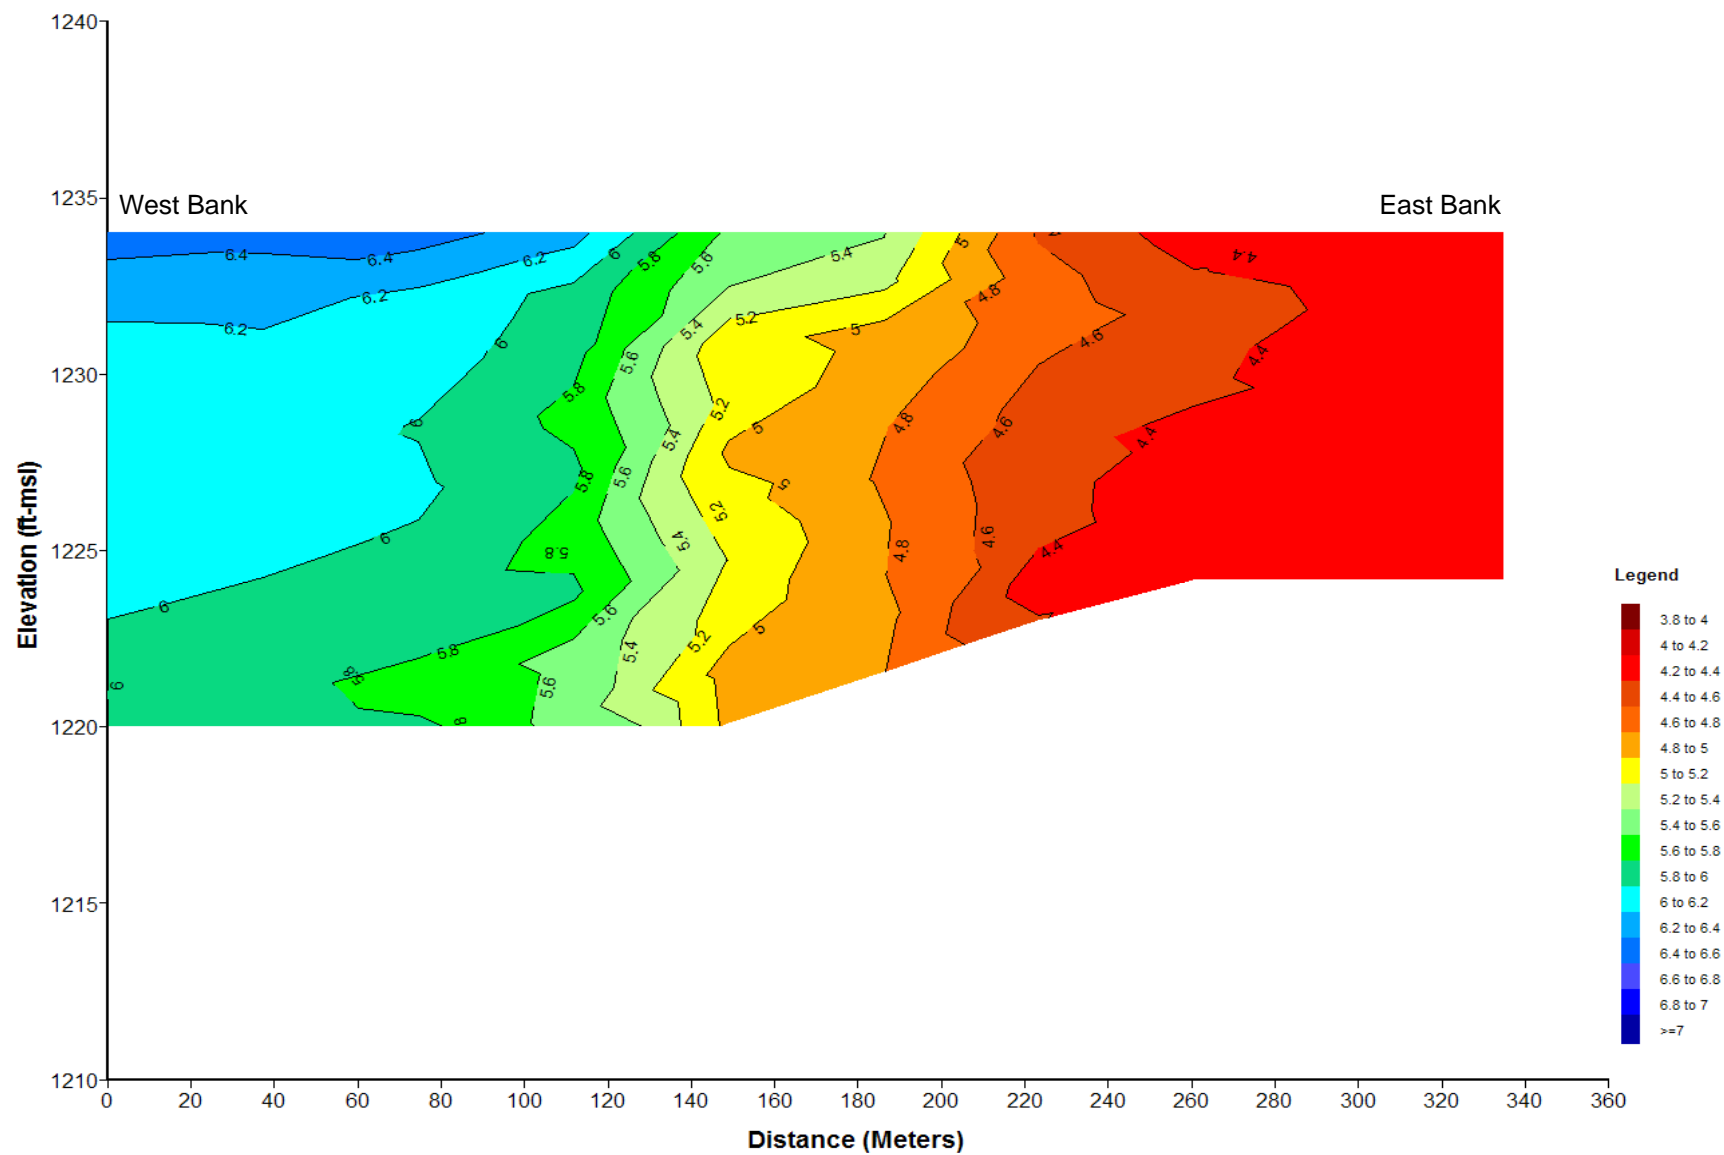
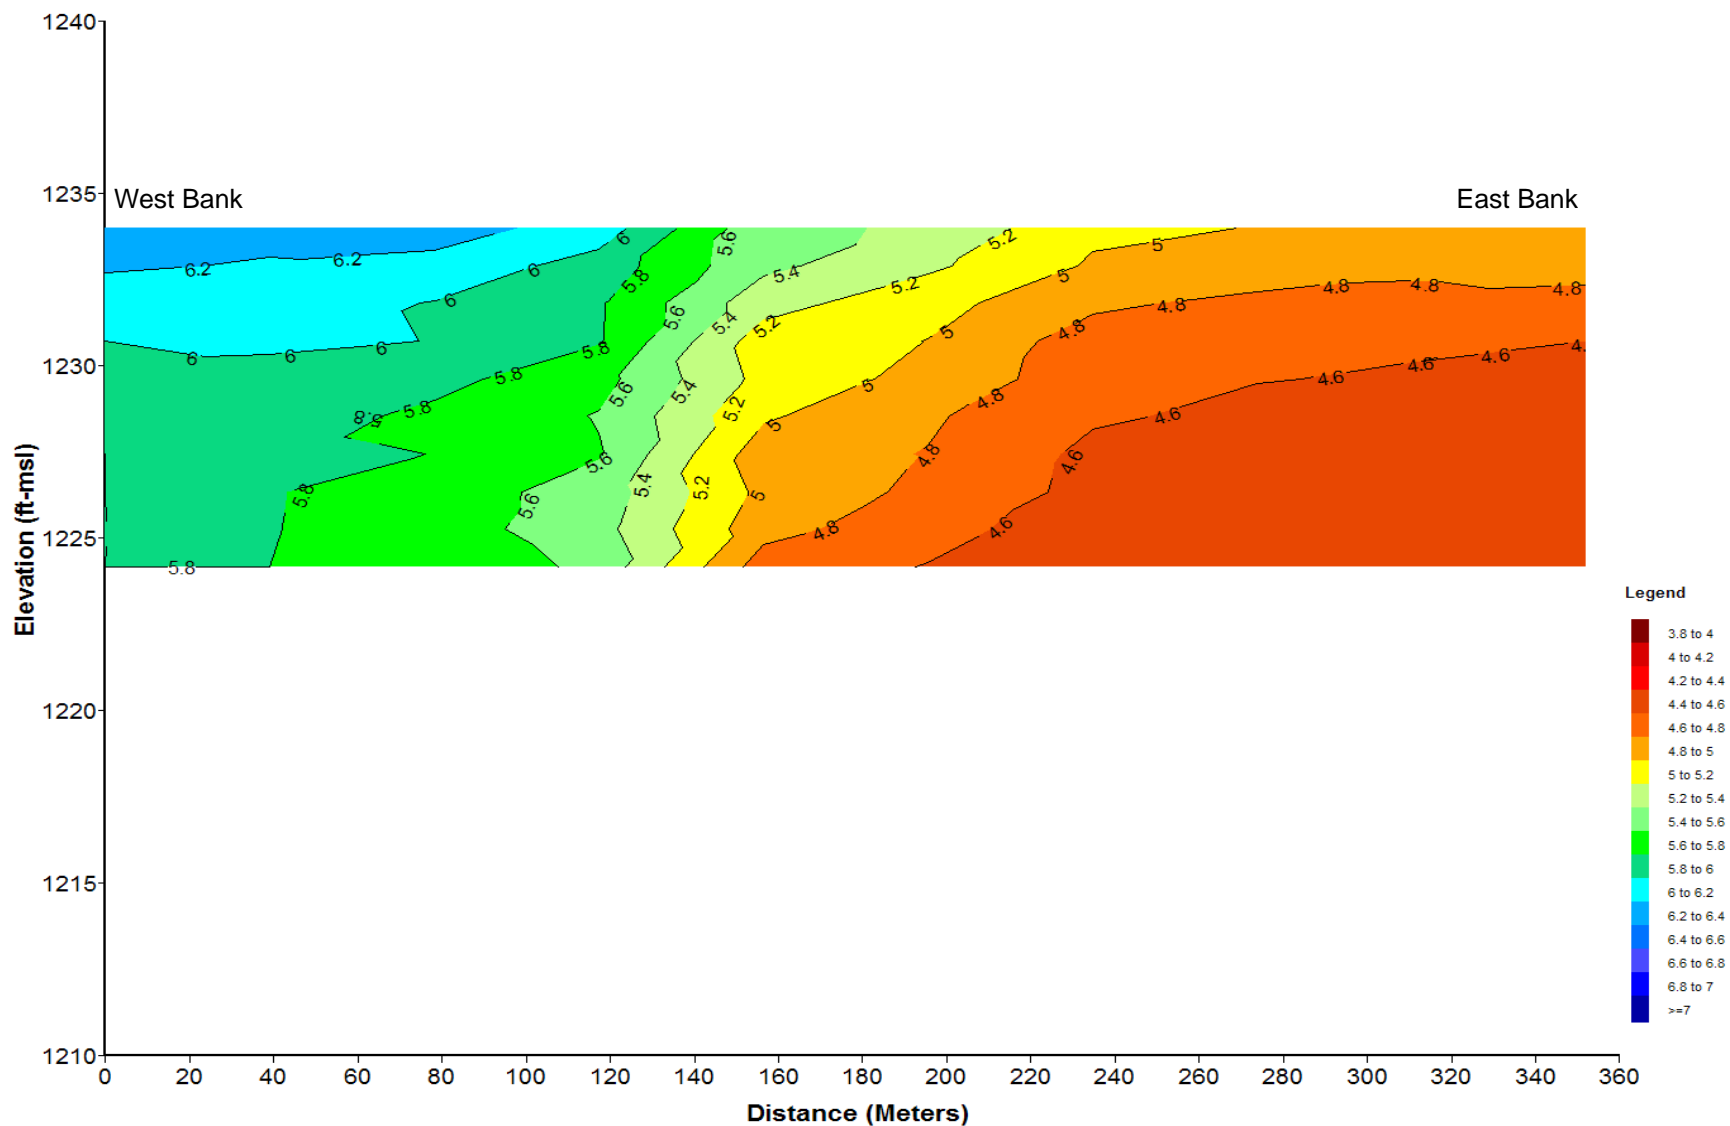
Figures 23, 24, and 25, respectively, display transect contour plots that were constructed to depict the dissolved oxygen concentrations measured across the Fort Randall Dam tailwaters at the near-dam (FTRTW3), spillway confluence (FTRTW2), and downstream (FTRTW1) sites on 3-August-2010. Figure 26 displays an aerial contour plot of the water-column average dissolved oxygen concentrations in the tailwaters based on the 1-meter incremental depth-profile measurements.
